Case Report

Aberrant posterior inferior cerebellar artery injury with C1 lateral mass screw placement: a case report and review of the literature

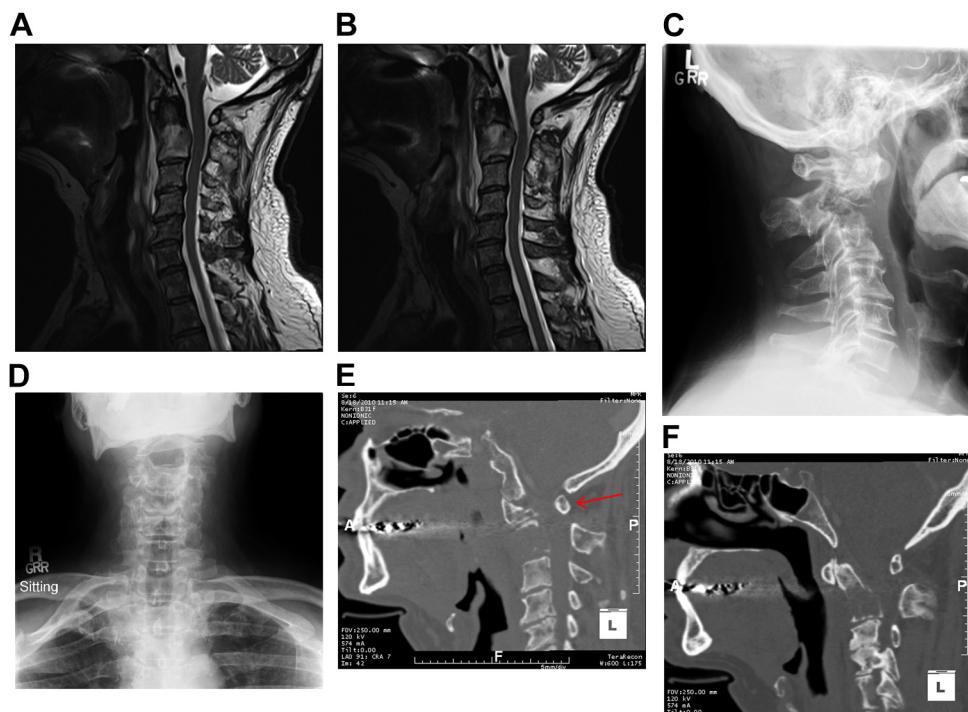
Fig. 1. (A and B) T2-weighted sagittal magnetic resonance imaging after pathologic fracture of C2. (C and D) PA and lateral X-ray showing pathologic involvement of C2 with kyphosis. (E and F) Sagittal computed tomography reconstruction preoperatively displaying the anterior displacement of C1 ring to C2 with resultant cord compression. The red arrow indicates the anterior displacement of the C1 ring secondary to the kyphosis at C2. PA, Posterior Anterior.

A 61-year-old man, with multiple myeloma and a destructive lesion at C2 was treated with chemotherapy and radiation to the cervical spine. On follow-up examination, the patient had progressive neck pain and repeat imaging showed progression of the disease with pathologic fracture and subluxation at C2 and substantial kyphosis (Fig. 1). He was neurologically intact but was felt to have an unstable cervical spine, so he was taken to surgery to stabilize his spine and prevent neurologic decline.

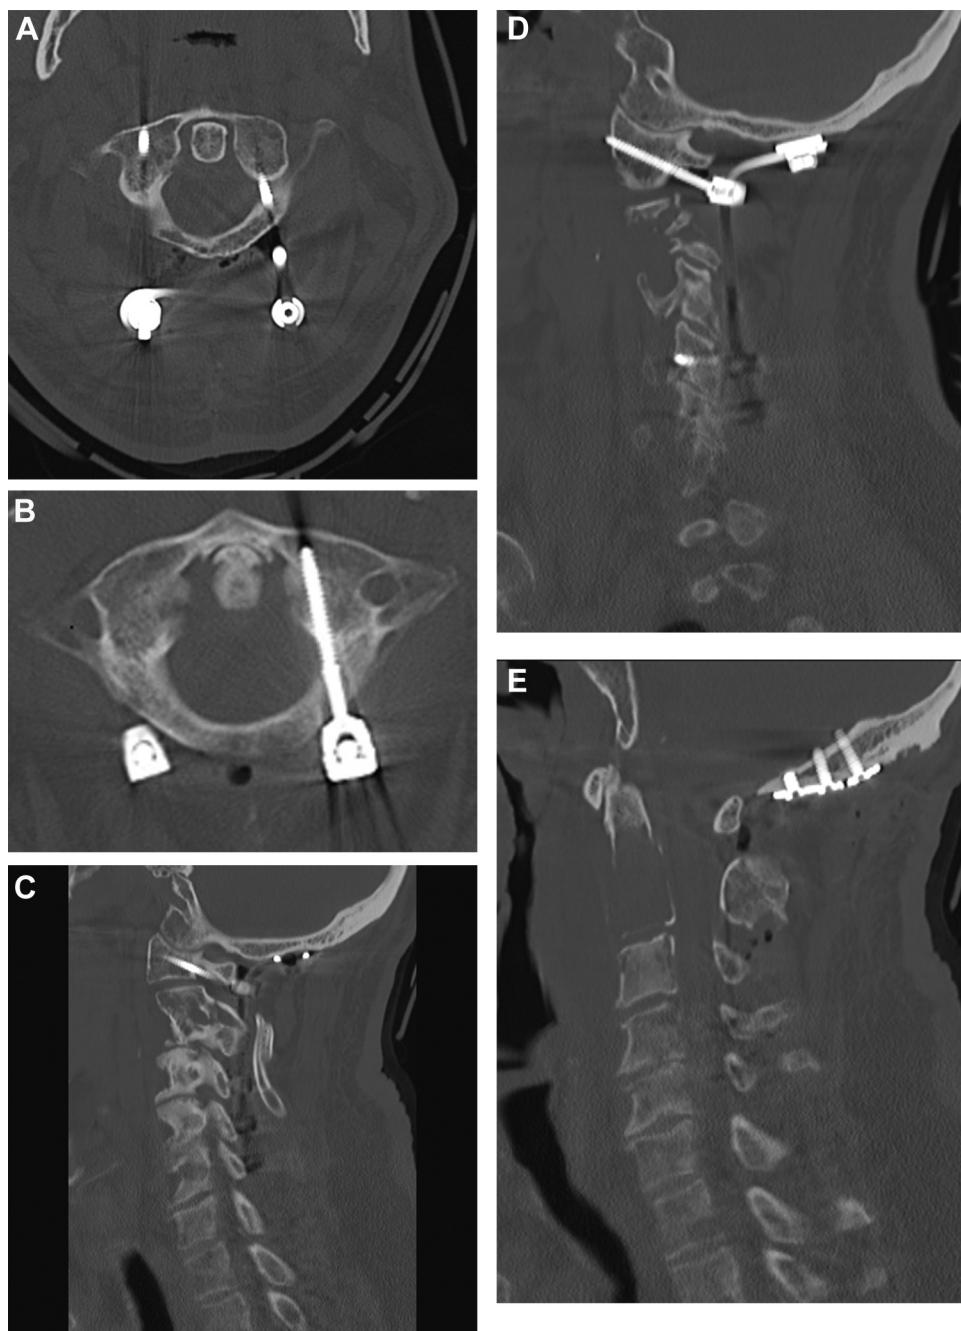
Fig. 2. (A and B) Axials of postoperative computed tomography (CT) of the C1 ring demonstrating good entry points and trajectories of the C1 screws. (C) Left parasagittal postoperative CT. (D) Right parasagittal postoperative CT. (E) Midsagittal postoperative CT demonstrating nice realignment of the pathologic fracture of C2 and correction of kyphosis.

The patient was placed into Gardner wells traction and underwent occiput–C6 posterior spinal instrumentation and fusion, including bilateral C1 lateral mass screw placement. C1 screws were placed by direct visualization of the C1 lateral mass with caudal retraction of the C2 roots. Neuromonitoring with motor-evoked and somatosensory-evoked potentials was used without any change from baseline prepositioning potentials. The case was completed without complication. Twenty-four hours later, the patient was noted to have trace weakness on the right side, dysmetria and slight dysdiadochokinesis, without nystagmus. Postoperative cervical computed tomography to assess position of the instrumentation demonstrated no malposition (Fig. 2). Magnetic resonance imaging/MRA revealed no

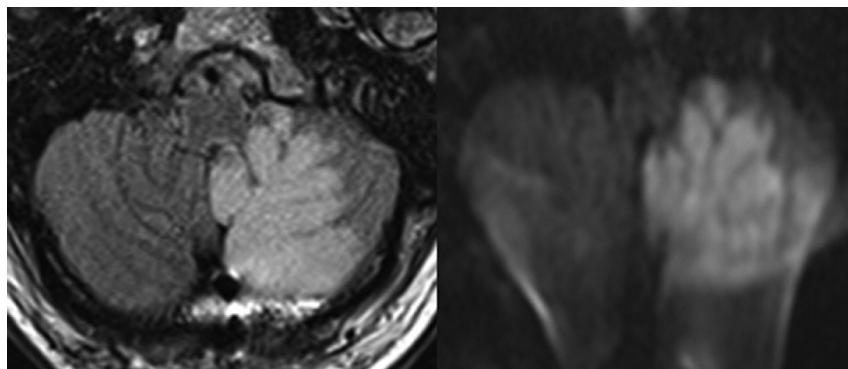
Fig. 3. (Left and Right) Diffusion weighted magnetic resonance imaging axial with acute left inferior cerebellar and small right parietal lobe infarcts in the distribution of the left posterior inferior cerebellar artery.

evidence of vascular occlusion in his internal carotid or vertebral circulation; however, it demonstrated an acute left inferior cerebellar and small right parietal lobe infarction (Fig. 3). A thorough stroke work up was performed, including a bubble echocardiogram, and no other causes for the patient's apparent embolic stroke was identified. Although a formal angiogram was not obtained, based on neurologic consultation and neuroradiologist opinion, this was felt to be in the distribution of the PICA. It was theorized that

caudal retraction of the vessel during C1 screw placement resulted in a thrombus that dislodged and resulted in the clinical picture seen in this patient. The patient was managed with anticoagulation and thrombolytic therapy with subsequent improvement of hemiparesis and dysarthria. On follow-up, the patient remained neurologically intact with only a slight amount of dyskinesia. He eventually succumbed to recurrent systemic myeloma and complications of the treatment 21 months postoperatively (Fig. 4).

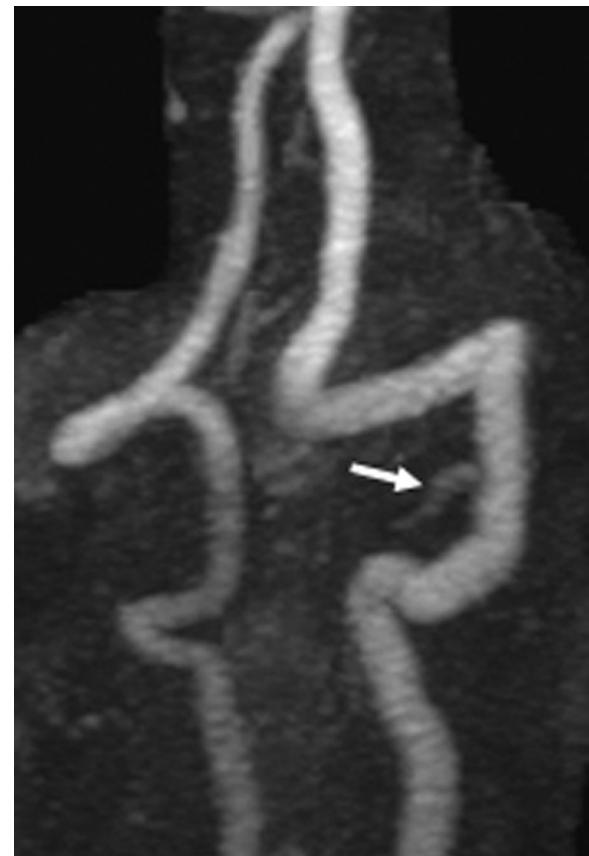
Fig. 5. Magnetic Resonance Angiography demonstrating the abnormal posterior inferior cerebellar artery origin (arrow).

We reviewed the patient's MRA with three independent fellowship trained neuroradiologists. The radiographic anatomy of the vertebral artery and PICA on the left side was reviewed, as this was the vessel of interest with the distribution of the embolic event. On the MRA, an abnormal location of the PICA origin was identified (Fig. 5). Computed tomography angiography (CTA) imaging confirmed the anomalous origin of this vessel, arising from the vertebral artery between the C1 and C2 transverse foramina. The artery then travels along the C2 nerve root, lying directly posterior to the C1 lateral mass screw entry point. The PICA followed the C2 nerve into the dura and coursed intradurally toward the cerebellum (Figs. 6 and 7)

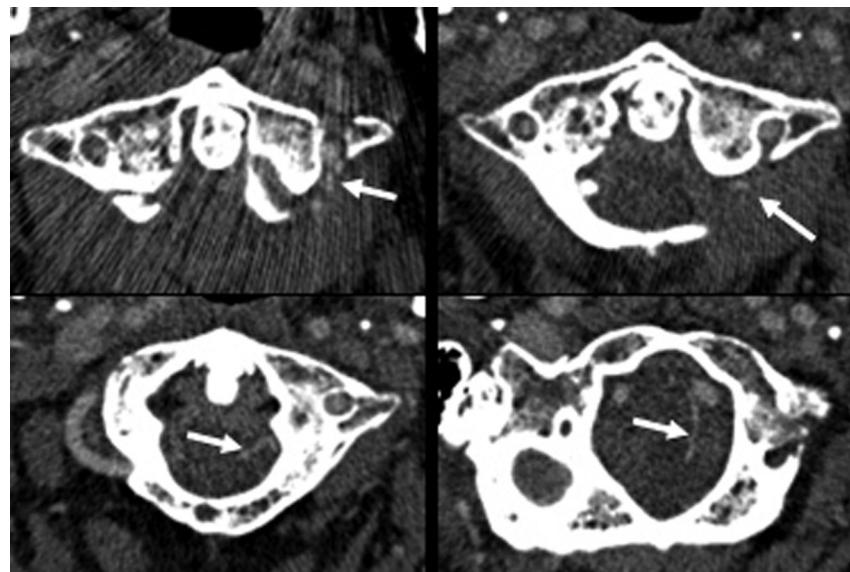
Fig. 6. Computed tomography angiogram demonstrating the course of the posterior inferior cerebellar artery that begins between the C1 and C2 foramen, following the C2 nerve root that then enters intradurally and progresses cephalad toward the cerebellum (arrows).

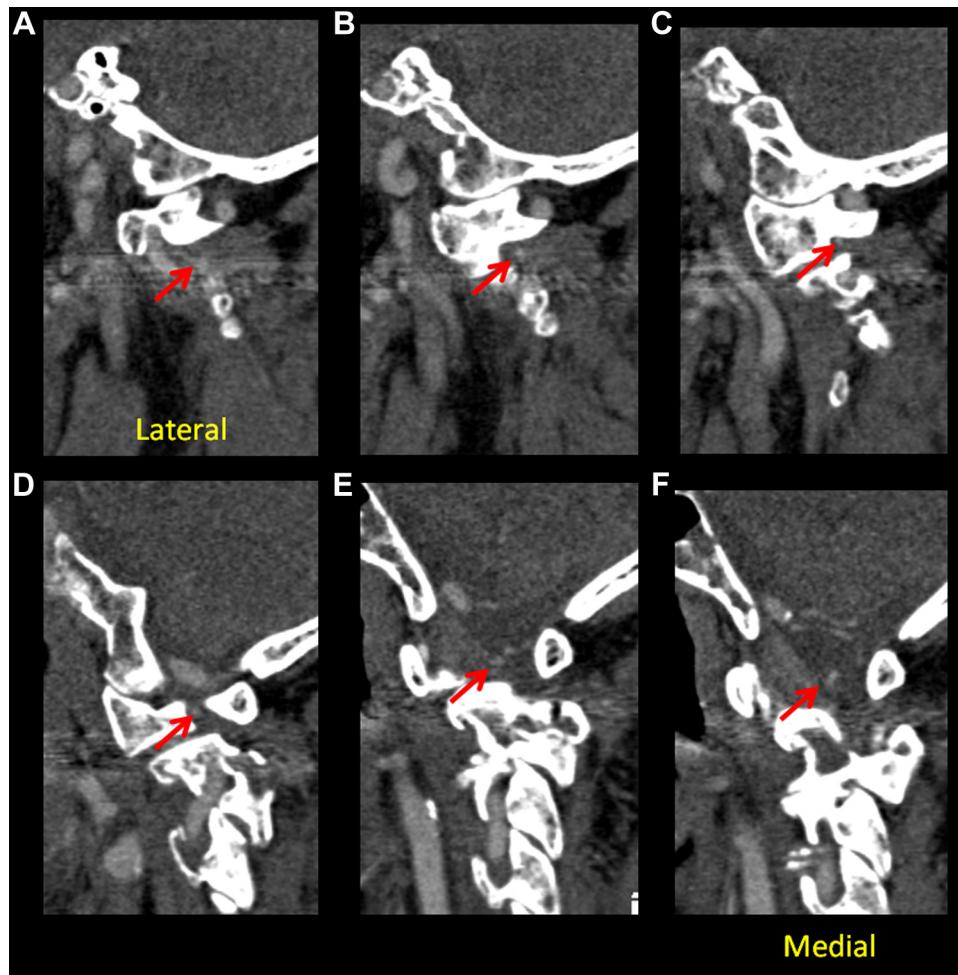
Fig. 7. (A-F demonstrating cuts from Lateral to Medial) Computed tomography angiography sagittal reconstructions demonstrating the relationship of the aberrant posterior inferior cerebellar artery and its relationship to the C1 lateral mass screw entry point. Red arrow follows the course of the PICA.

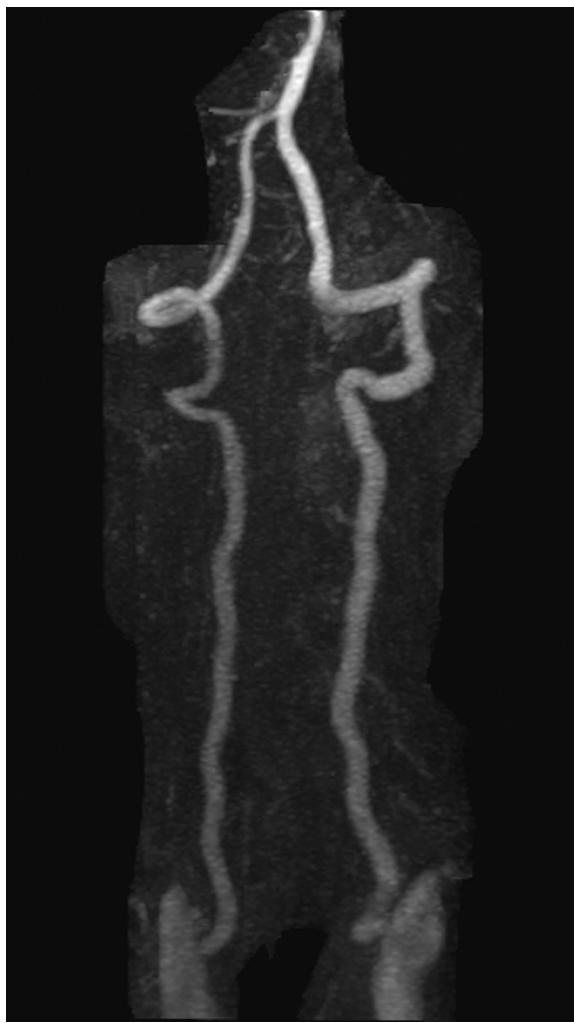
Fig. 8. MRA of complete vertebra basilar system to illustrate the integrity of the vertebral artery.

assessment, they were unable to visualize arterial injury such as dissection or intimal injury. However, we aren't able to definitively state based on imaging that this did not occur. No arterial injury was seen in the subaxial spine (Fig. 8). In discussion with our neurologist and radiology colleagues, we agreed on a theory based on all evidence that a thrombus had dislodged and resulted in the embolic stroke.

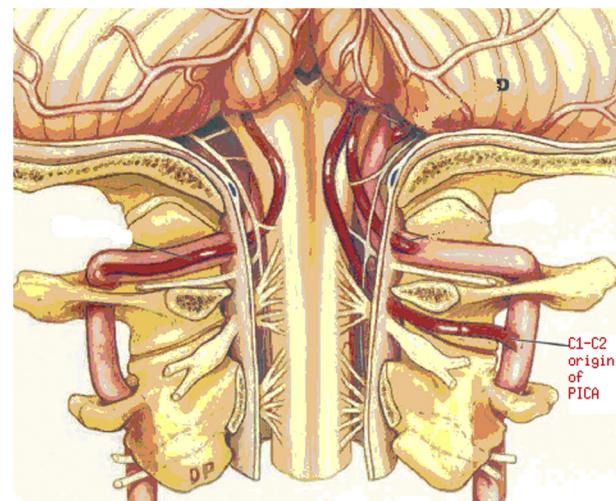
Fig. 9. Graphical representation of the anomalous PICA variant described in this case (Used and modified with permission from Journal of Neurosurgery [6], Publisher Excelsior). PICA, posterior inferior cerebellar artery.

Based on our literature review, this is the first reported case of an aberrant PICA resulting in a stroke secondary to C1 lateral mass screw placement. One additional article describes the specific anatomic variation of PICA seen in this case. This was an angiography study, describing the different extracranial PICA variants over a 10-year period [5,6]. Discussion of abnormal PICA anatomy along with other vertebrobasilar arterial differences to reduce surgical complications is prudent (Fig. 9).
